Reconstruction of a Jomon Period Sod Roof Pit House: Burnt Pit Dwelling of Goshono Site, Ichinohe Town, Iwate Prefecture

Reconstruction of a Jomon Period Sod Roof Pit House (2): Burnt Pit Dwelling of Goshono Site, Ichinohe Town, Iwate Prefecture

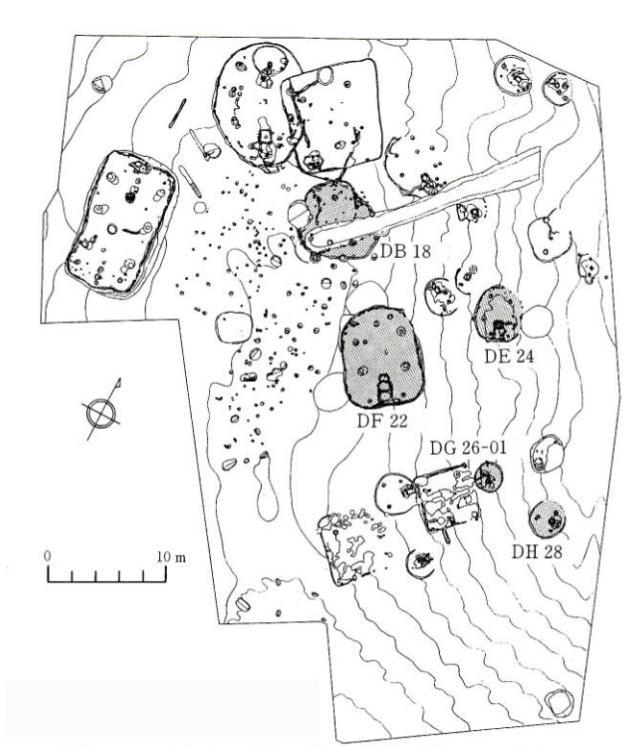
Figure 2 : Feature Remains of West Research Area

The large-size pit house DF22 is located in the western research division in the central area of the site. Surrounded by four coexisting houses, DE24, DH28, DG26, and DB18, from the end of the Middle Jomon period, it may be presumed to be some sort of "main house." All five of these buildings were burnt, but because DB18 and DE24 are close in proximity it could be that one was a replacement for the other, one can reasonably assume that at least four buildings of large, medium, and small

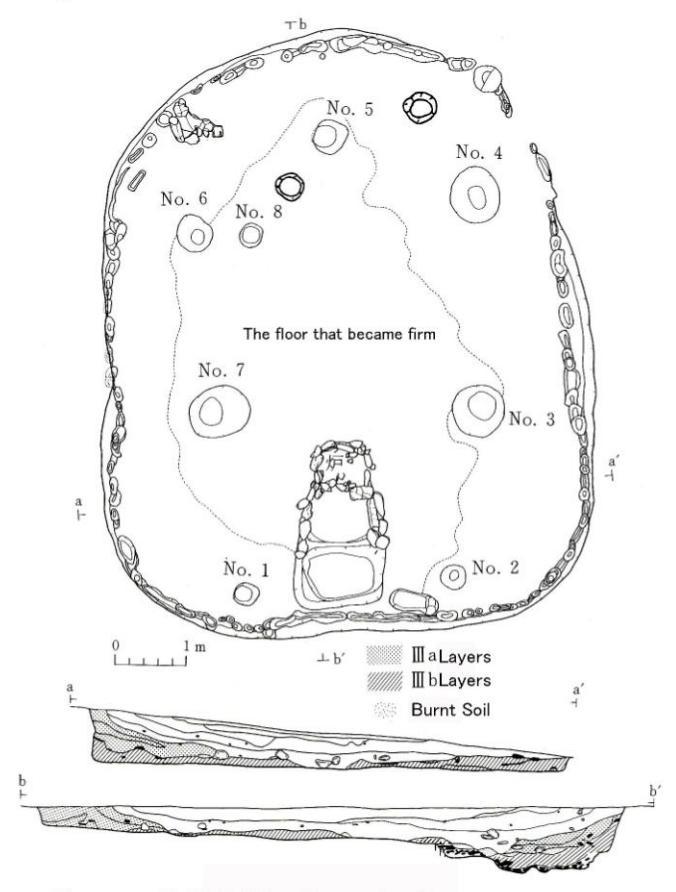
Figure 3 : FD22 Building Excavation Map

DF22 is a long elliptical building with dimensions 8.4 meters north-south and 6.8 meters east-west with the south wall being slightly linear. Surrounding the pit house is a gentle slope descending from the west to the east. This affects the height of the pit walls, which are highest on west side at 70 centimeters and just 10-15 centimeters on the east, making a difference of 50-60 centimeters between the two sides. A stone hearth is near the southern wall inside the pit, and the distance between wall and pit is 1.6 meters and has been dug to a depth of 30 centimeters in two steps. Burnt earth was found not only inside the stone hearth but also in the excavated area located on both sides of the northern part of this circle. This area also corresponds to the hearth. The stones surrounding the hearth are mostly andesite, but it also used sandstone, granite, and chert. The pit floor is flat for the most part, although the northwest side is 20 centimeters higher than the southeast side. Although the entire surface was dug to the loam surface of the ground, in the center of the pit house (the area inside the main pillars) has tamped earthen floors (hariyuka). In contrast the floors have not been tamped along the west wall moving north in an area of 1 meter and 1.5-2 meters along the east wall. However, the entrance area around the south wall, especially on the east side, has tightly packed tamped earthen floors. It is likely that inhabitants of this dwelling used this area at the entrance and in a horseshoe pattern in the center in their daily lives where they laid mats on the ground.

Eight postholes have been confirmed. As the postholes P6 and P8 are located adjacent to each other, from the indentation it may be thought they used a split log or intentionally used two pillars in the same location. The dimensions of each posthole are listed in Table 1. In particular, the postholes P3 and P7 are quite large, indicating the use of substantially large logs.

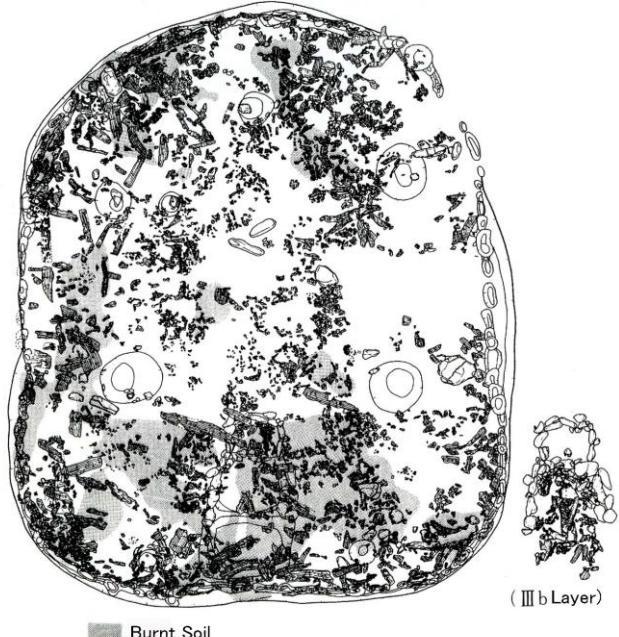
Figure 4 : Distribution of Charrde Wood and Burnt Soil

Carbonized remains were found throughout most of the pit house (see Figure 4) and may be broadly divided into the following three groups.

- Group A: Remains scattered above layer 3. All are fragments distributed throughout all of the south side and in the central area. On the same south side these fragments were excavated together with gravel (Figure 5).

- Group B: Within layer 3, well-preserved charred wood remains were distributed throughout the entire pit area. These charred remains were particularly thick along the walls and layered on top of each other. In the center the remains were floating somewhat above the floor surface. It is possible to divide the direction of these wooden remains into several directions (Figure 6).

- Group C: Excavated remains below the layers 3 along the pit floor were largely limited to the central area. The remains consisted of thin broken pieces of approximately 10 centimeters and 20-30 centimeters in length distributed no set direction. The remains were concentrated within the circumference marked by the postholes, with thin strips located inside and slightly longer pieces located outside.

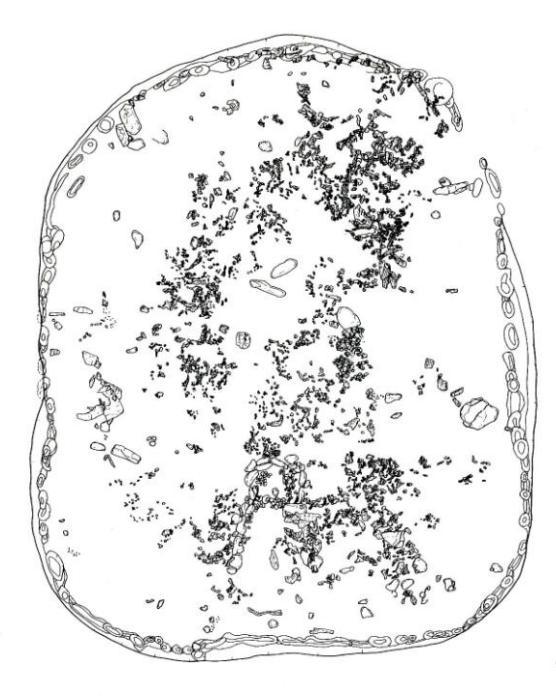
Figure 6 : Layer C Charred Wood

Analyzing the relationship between the charred remains and burnt soil, in the central area the charred remains from Group C are distributed above the pit floor, above which is soil from Layer 3-b, and above Layer 3-b is a thin layer of burnt soil and thin strips of charred wood. Along the pit walls, while a portion of charred remains is located on the pit floor, remains are deposited in Layer 3-a or—when there is no Layer 3-a—in Layer 3-b, above which are charred remains from Group B, and burnt soil is distributed above this these remains.

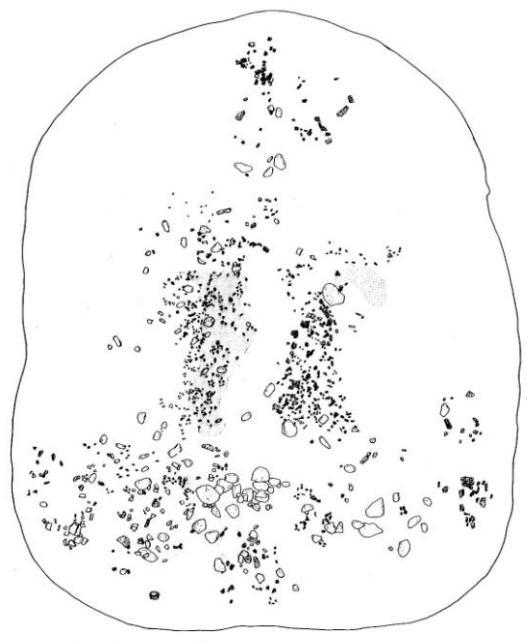
Figure 5 : Layer A Charred Wood and Burnt Soil

Next, examining the distribution of burnt soil, as figures 5 and 6 indicate it may be identified above layer three and in layers three and two. The burnt soil in the above layer three is concentrated in the central area of the pit and is distributed throughout the same level and is comparatively thin. In comparison, the burnt soil within layer three is located below layer 3-a and the level increases as it approaches the wall. On the west wall moving south from the middle, the wall itself was burnt.

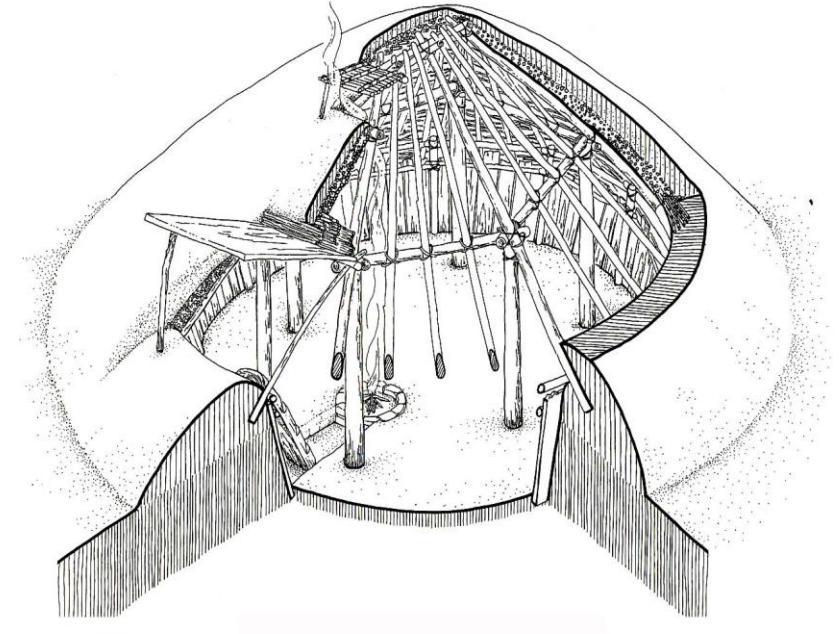
Figure 1 : Building DE24 Reconstruction Model

The height of a pit dwelling cannot be determined exactly without excavating the remains of pillars. For the reconstruction of the medium size pit dwelling DE23, we located the beams and girders at a height above that of an adult Jomon person standing upright (approximately 160 centimeters from the floor). Furthermore, assuming that there was a ridge surrounding the pit, the roof was set at an appropriate gradient (approximately 35 degrees). The result of this recreated a living space of human scale that had never been seen before in reconstructed dwellings.

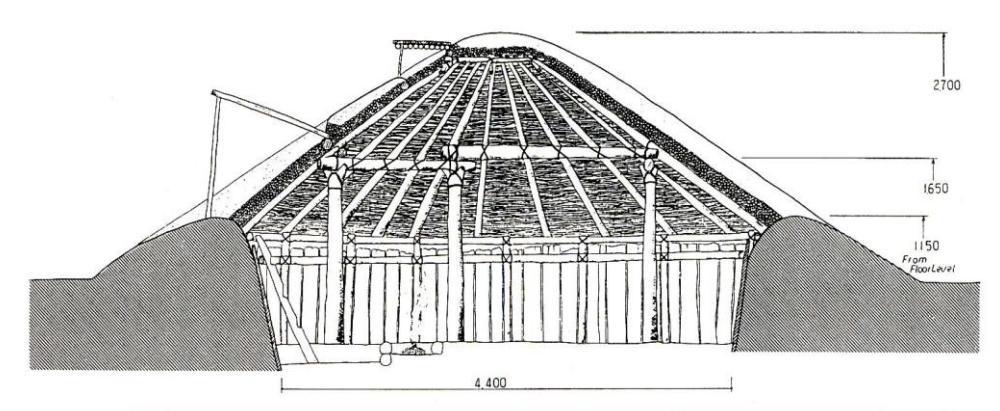
Figure 2 : Building DE24 Cross Section(North-South Facing)

This method of reconstruction may fundamentally be thought effective for medium and smaller size pit dwellings, but this same method is not appropriate for the reconstruction of large-size pit houses. The reason is that the dug out pit is deep, and when conducting reconstruction one must first estimate the depth of the pit in comparison to the former ground level as well as the height of the surrounding ridge. If one is able to discern these numbers, by restricting the gradient of the sod roof to around 35 degrees,¹ it becomes possible to reconstruct the overall height of the dwelling.

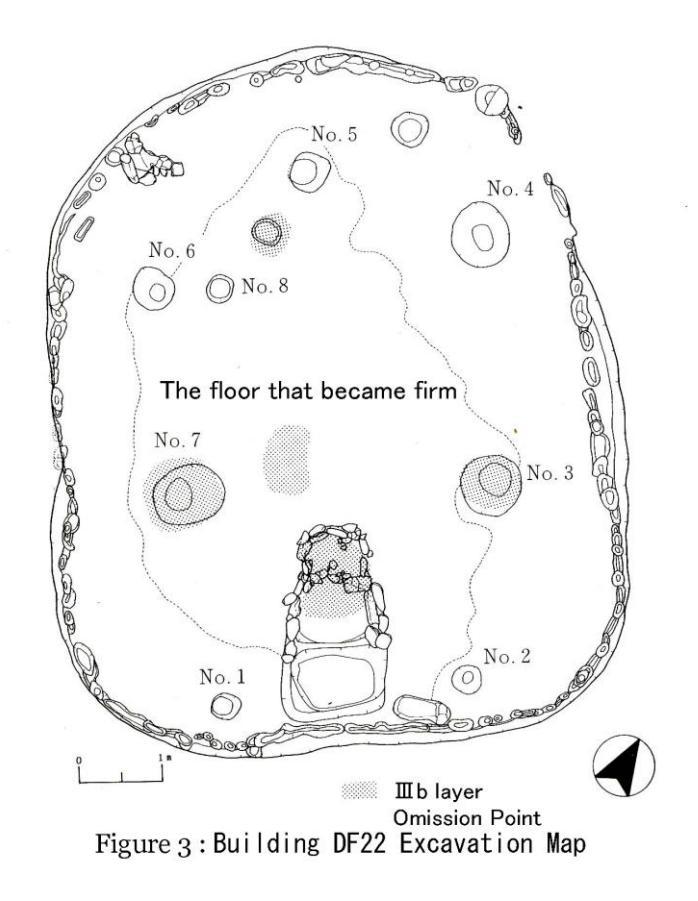
On the top surface of Layer 3b, a depression of black-brown soil from Layer 2 has been identified (Figure 3). In particular, directly above the hearth and again on the north side, Layer 3b is broken in an area, respectively, of 100 centimeters north-south and 120 centimeters east-west and 84 centimeters north-south and 52 centimeters east-west (estimated). As there was no dirt from the roof above this, these have attracted attention as traces of windows used for ventilation. Curiously, amongst reconstructed pit dwellings in Japan, even those with thatch roof, more than a few are built without windows for ventilation of smoke. However, without ventilation the residents of pit houses would die of suffocation. The burnt dwelling remains at Goshono site represent a breakthrough in identifying traces of ventilation windows in these well-sealed dirt roof dwellings, which at the same time may be regarded an expected result.

Other than this, as may be seen in Figure 3, there are interruptions in Layer 3b in the area above postholes No3 and No7, as well as in-between postholes No8 and No5. As explained before, with No3 and No7 the pillars remained standing as the dirt from the roof collapsed. With the area between postholes No8 and No5, there is a depression approximately 5 centimeters in depth in a circular shape. Moreover, as the bottom of this depression is extremely hard, it is possible that a pillar had been standing here.

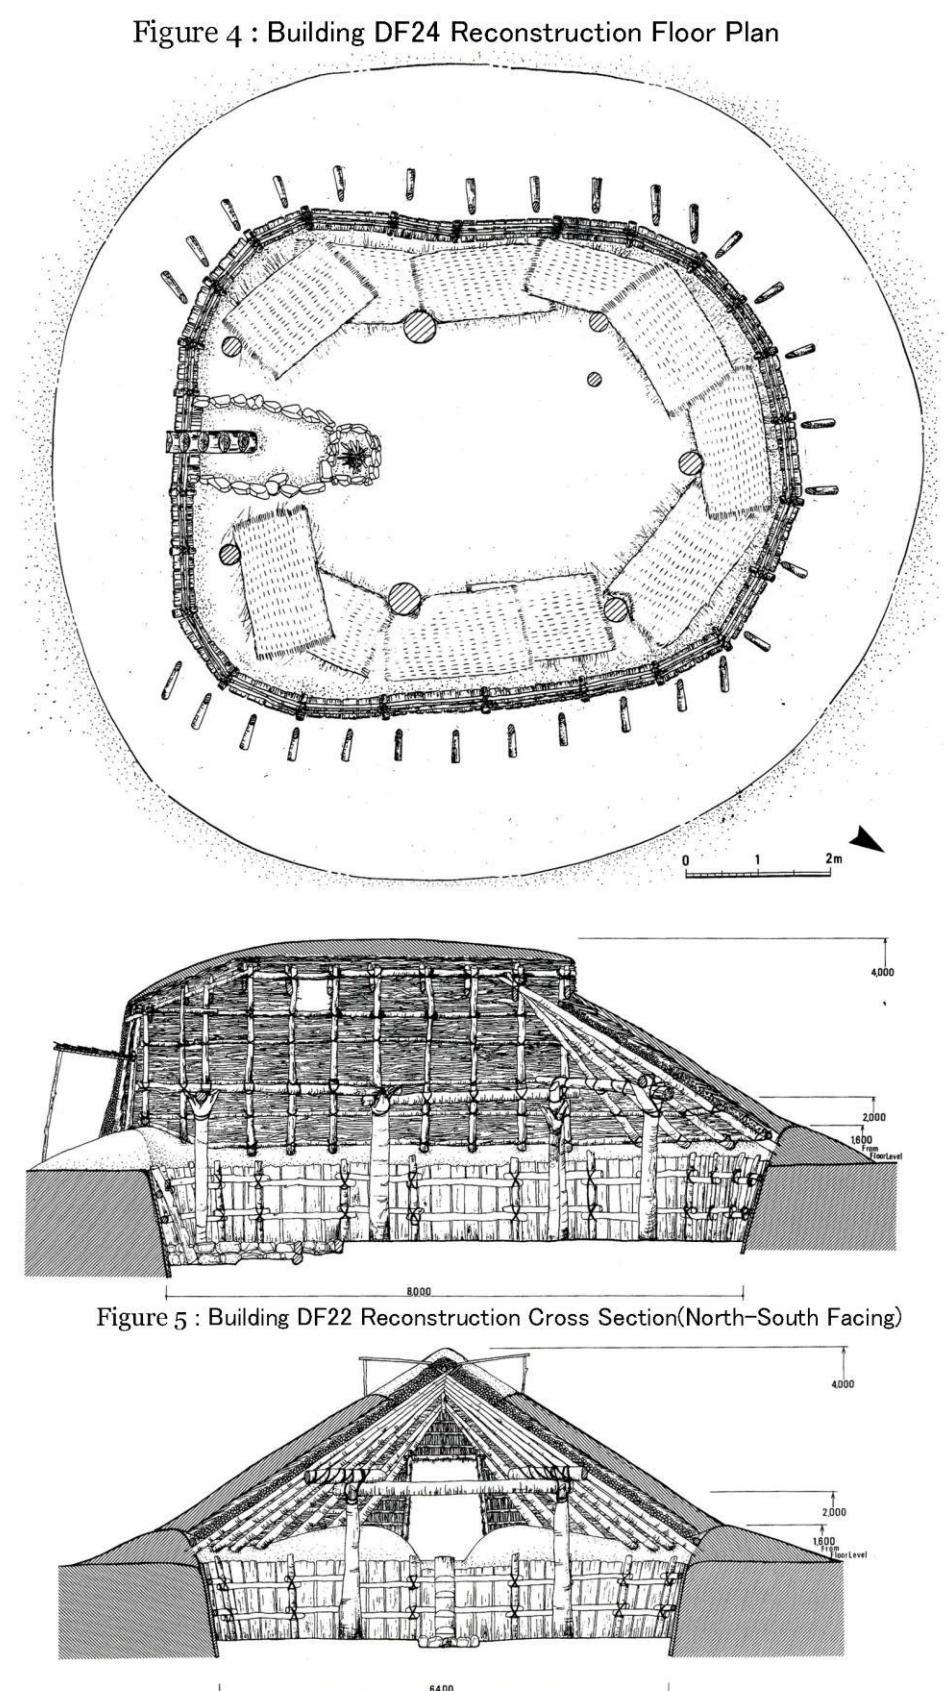
Figure 6 : Building DF22 Reconstruction Cross Section(East-West Facing)

While no clear data was obtained on the width or height of the ridge for DF22 at Goshono site, it is possible to reconstruct the building with the depth from top of the ridge to the bottom of the floor ranging between 1.4 to 1.7 meters high. This would make it close to the height of a Jomon person. For this reconstruction, the depth of the pit including the ridge was set at 160 centimeters with a roof gradient of 35 degrees. Accordingly, the height of the pillars and beams was approximately 200 centimeters above the floor, the total height of the pit house was about 400 centimeters from floor to top, and the height from ground level was 310 centimeters.

The dirt from the roof that collapsed inside the pit house forming Layer 3b was found to be a depth of 10 to 15 centimeters in the central area (inside the area demarcated by the main pillars). In contrast, the outer area (outside the main pillars) is mixed with dirt from the collapsed ridge wall, making it impossible to exactly identify the dirt from the roof. However, examining the condition of the sediments in Layer 3a and 3b it is conceivable that the dirt was thicker towards the ridge and was at least 20 to 30 centimeters thick at the walls.

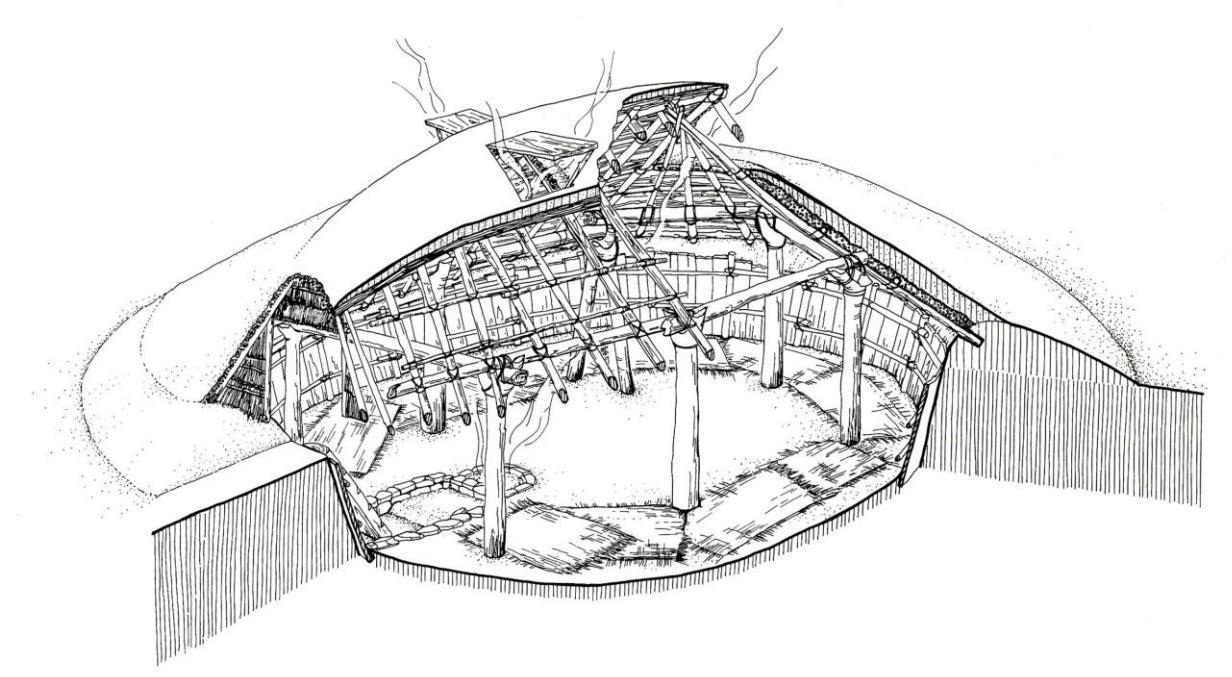
Figure 7 : Building DF22 Reconstruction illustration Model

From the above discussion, DF22 is thought to be a sod roof pit house built with a gabled entrance and a hipped roof circular structure at the opposite end. That is, it is a shelter covered in dirt similar in appearance to an igloo (kamakura) with an entrance dug into the side of a mound of snow. Examined ethnographically, it is similar to the toi-chise ("house of dirt") of the Sakhalin Ainu,² although built without the chimney used in these dwellings. With this kind of igloo shaped sod roof building, the ventilation window presents a great contradiction. For this reconstruction, one window was built with a push-up door above the hearth on both sides of the roof ridge and another between the rear roof and the ridge of the main building. The actual structure, however, is unclear. Also, the Koryak of Kamchatka Peninsula, the Aleut of the Aleutian Islands, and North American Indian peoples such as the Thompson and Modoc built pit houses with windows that were used for going in and out of the building. This kind of folk living was seen in ancient groups such as the Mohe in ancient Manchuria and Mahan in the southern Korean peninsula, and in ancient Japan the Tsuchigimo clans were vividly depicted in the" Fudoki" as living in dwellings reminiscent of these window-entry pit houses. However, window-entrance pit houses are always built with side-entrances, with the window used by adult men and the side-entrance by women and children, or in other cases with the window-entrance used in winter and the side-entrance used during summer. At Goshono site, it is not possible to say that there were no dwellings with window-entrances, for the above reasons DF22 was built similarly to the igloo-shaped toi-chise built by the Sakhalin Ainu, with the main entrance located along the wall near the stone hearth.
